**CONSOLIDATED SEWER MAINTENANCE DISTRICT
CONDITION ASSESSMENT PROGRAM REPORT
PROJECT NO. Y0TV1011A**

**CONDITION ASSESSMENT REPORT
COUNTY OF LOS ANGELES DEPARTMENT OF PUBLIC WORKS
CONSOLIDATED SEWER MAINTENANCE DISTRICT**

PROJECT NAME:	Y0TV1011A	PROJECT MGR:	Eric Liu
PROJECT DATE:	09/01/2011	CONTACT NO:	(626) 300-3369
SUP. DISTRICT(s):	1	MAP PAGE(S):	1861, 1862, 1915, 1916
Report By:	Eric Liu	Report Date:	11/27/2013

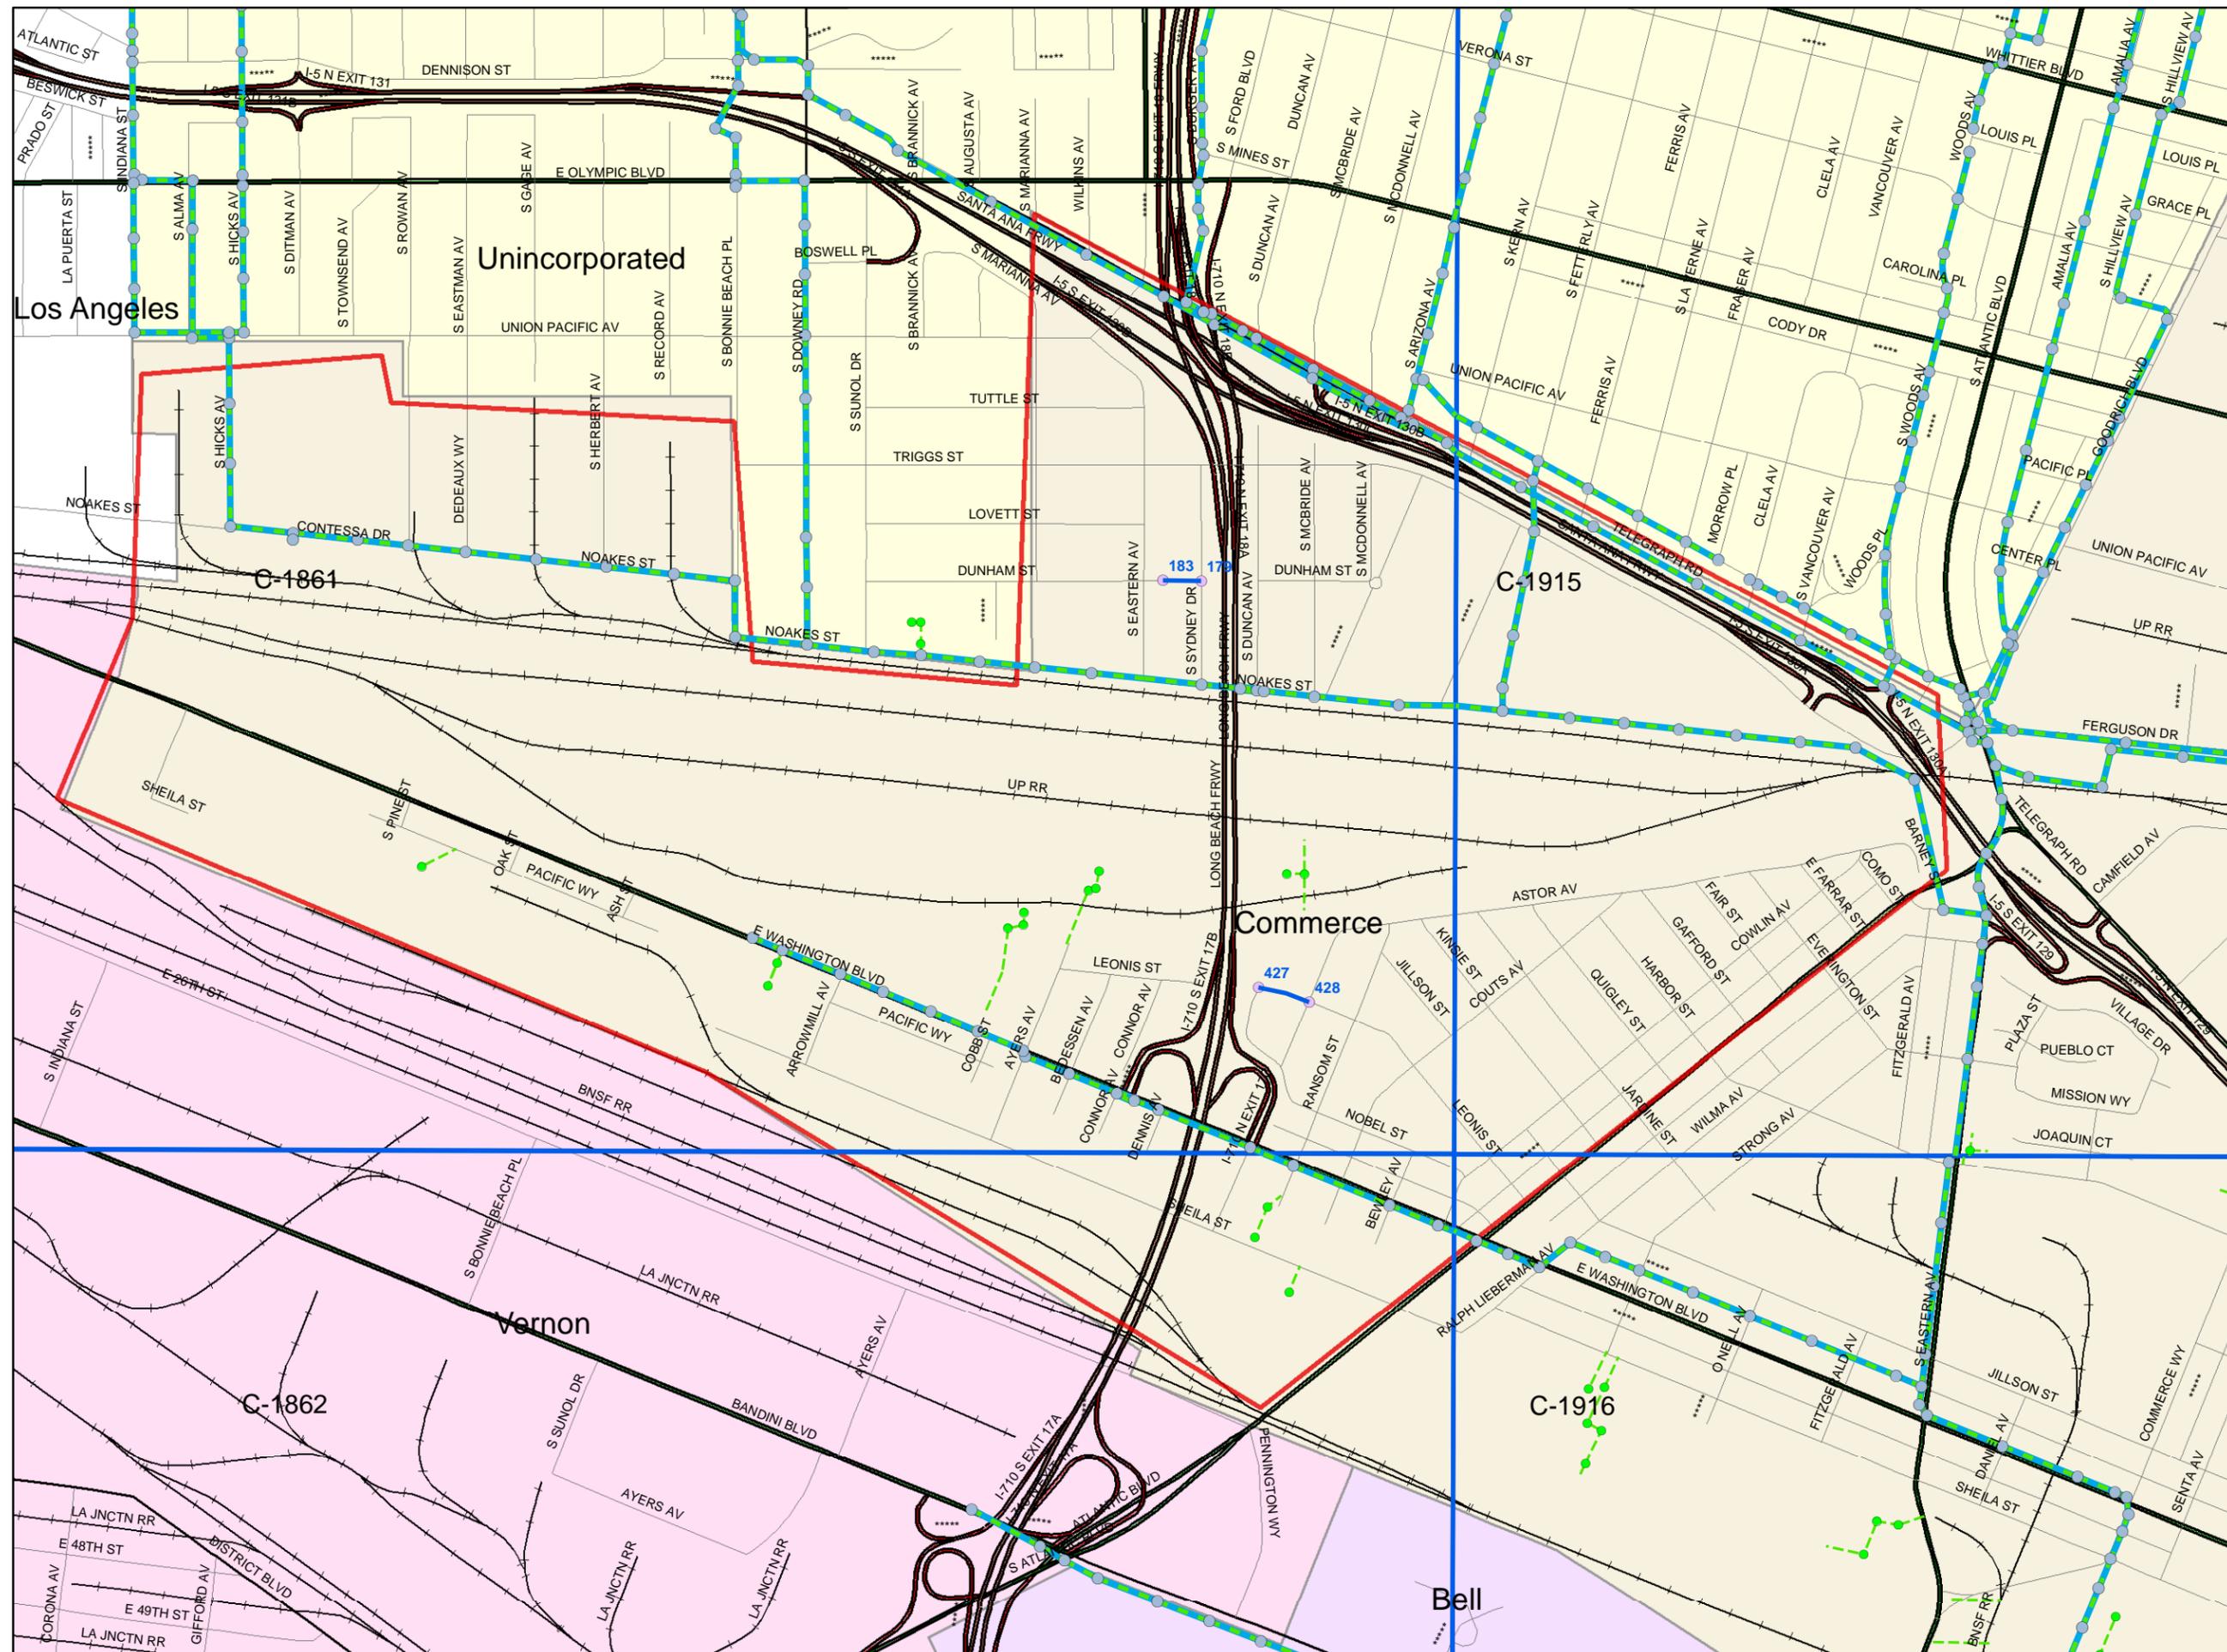
HIGH WATER LEVEL

Item No.	QMR	Start MH	End MH	Street	Observation	Percent Capacity: Location
1	4531	1861-0179	1861-0183	DUNHAM ST	Camera under water	(30% - 70%): 51' - 115'
2	3221	1861-0428	1861-0427	LEONIS ST	Sag	(30% - 50%): 45' - 117', 190' - end MH

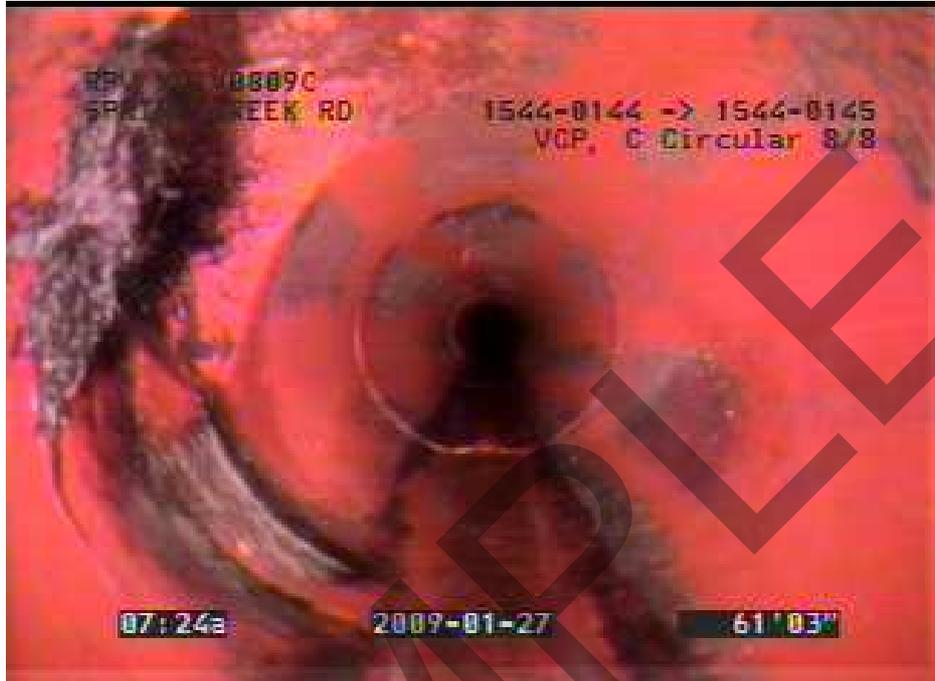
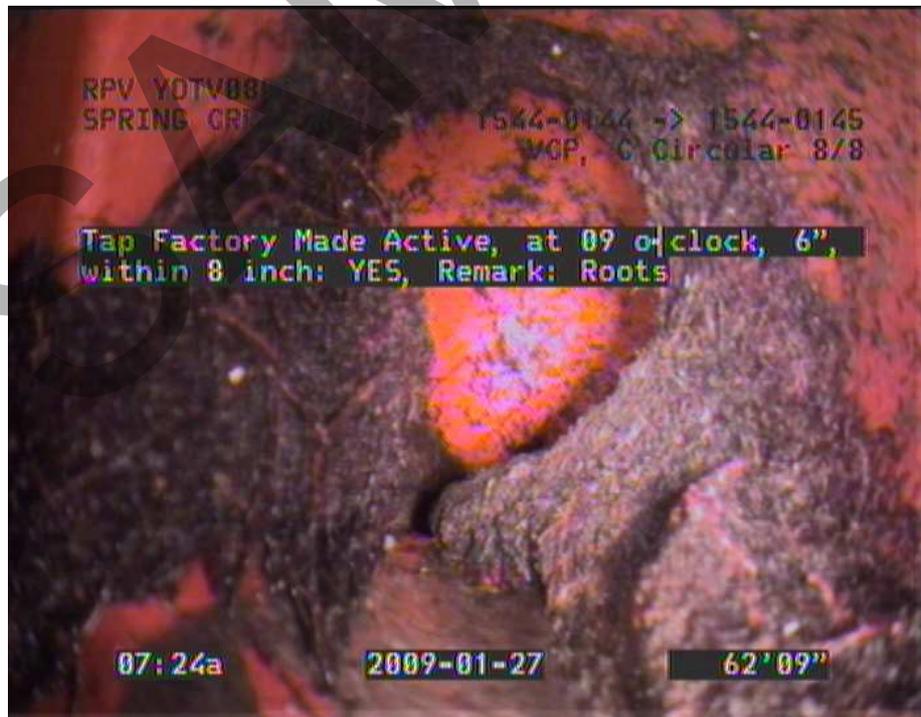
XXXX
Roots at Lateral Connection

Using closed-circuit television (CCTV) camera technology, the District recently televised the sanitary sewer mainline and discovered the presence of roots in your sewer lateral connection. The intrusion of the roots from your lateral may block the flow of sewage in the mainline sewer causing a sanitary sewer overflow upstream of your property.

Since the CCTV inspection, the sewer mainline has been cleaned and blockages from root growth have been removed; however, the root blockage in your sewer lateral is still present. As the property owner, you are responsible for the entire length of the sewer lateral, which includes the portion that extends beyond the property line into the public right of way. We request that you contact a qualified plumbing contractor to service your sewer lateral within 90 days to remove roots and any other obstructions that may cause a sewage backup.

During your lateral service, your plumbing contractor must protect the District's sewer mainlines from dislodged roots and other debris by utilizing catcher baskets at the manhole downstream from your lateral connection.

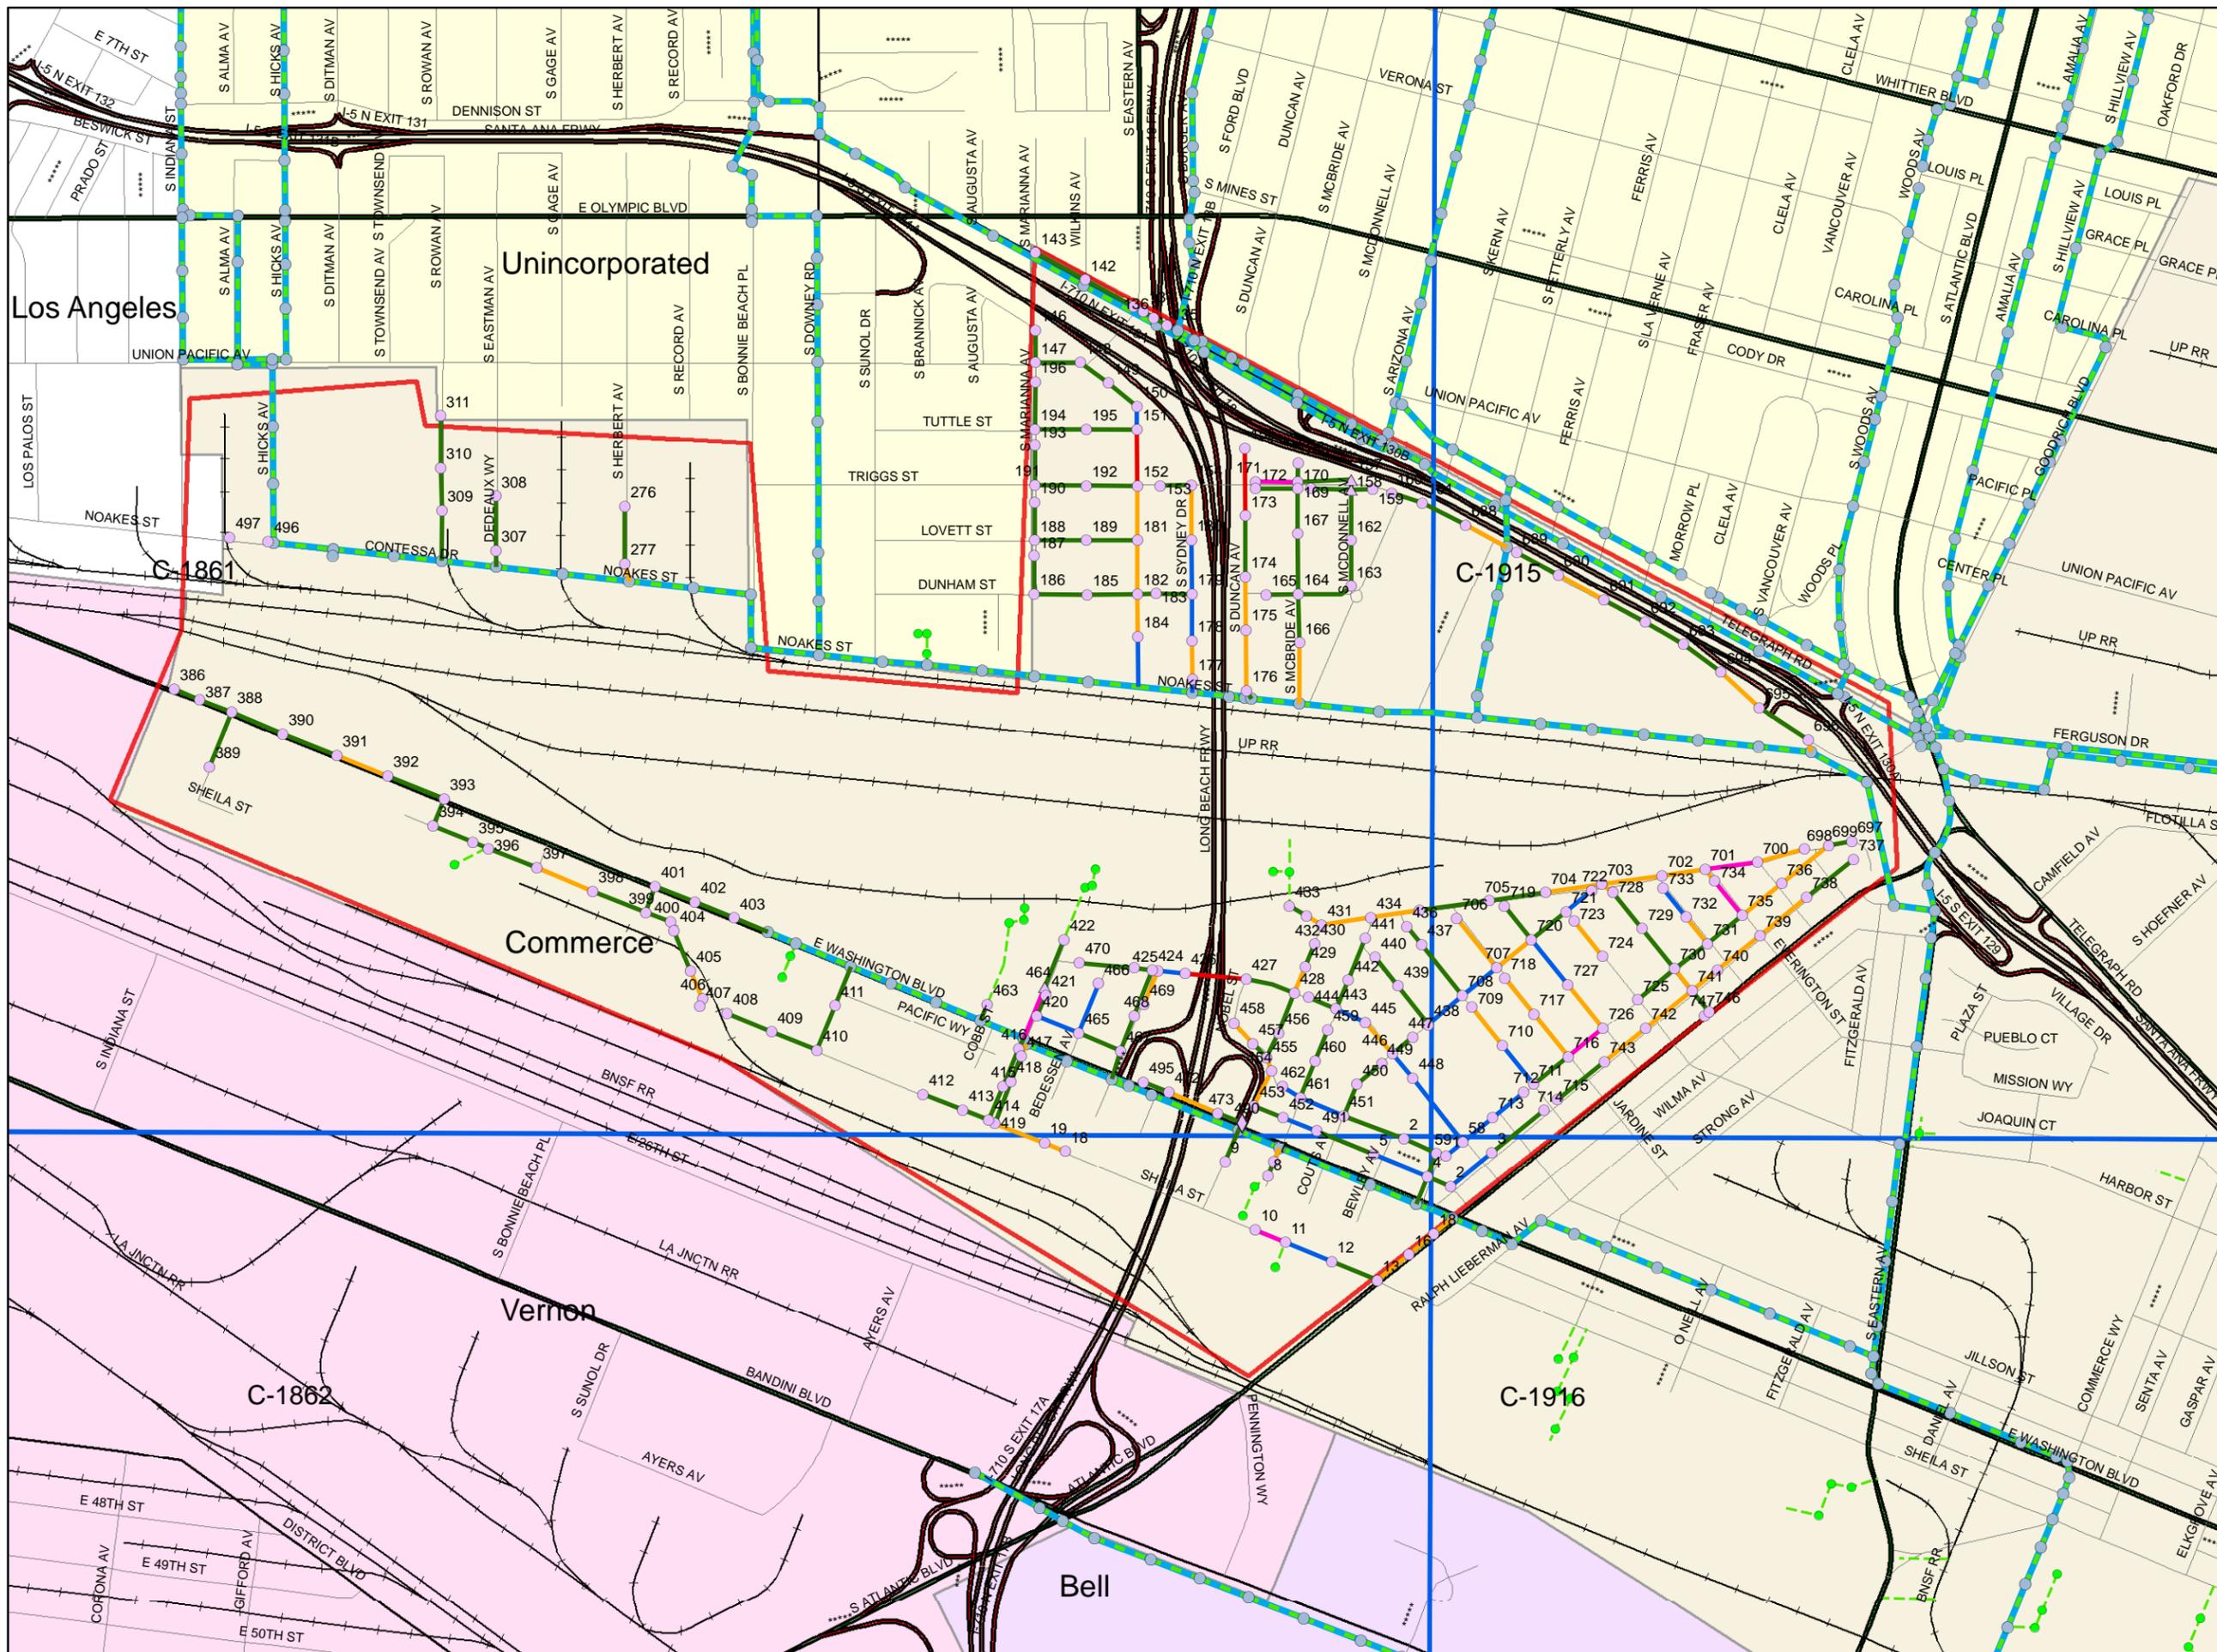
QUICK
STRUCTURAL
RATING
(QSR)

Item No.	QSR	Start MH	End MH	Street	Observation: Location	Proposed Corrective Method	Length of Repair (FT)
1	5235	1861-0426	1861-0427	LONG BEACH FRWY	Fractures: 4' - 10', 68', 75', 79', 262', 276', 304', 310'; medium offset: 64'	Lining: MH to MH	372
2	5221	1861-0151	1861-0152	EASTERN AV	Fracture: 46'; broken with visible void: 120'; concrete sewer	Emergency Point Repair (completed: 03/11/13); Lining: MH to MH	312
3	5141	1861-0173	1861-0155	DUNCAN AV	Fractures: 172', 184'; hole soil visible: 241'	Structural integrity intact. No action needed.	
4	4137	1915-0734	1915-0735	EVERINGTON ST	Fractures: 6', 29', 155', 209'	Structural integrity intact. No action needed.	
5	4135	1915-0700	1915-0701	ASTOR AV	Fractures: 42', 264', 267'	Structural integrity intact. No action needed.	
6	4131	1861-TRNK	1861-0464	AYERS AV	Fractures: 137', 312'; concrete sewer	Lining: MH to MH	325
7	4131	1862-0010	1862-0011	SHEILA ST	Fracture: 51', 197'; hole at base MH 11	CSMD will repair MH base.

8	4100	1861-0171	1861-0169	TRIGGS ST	Fractures: 83'; concrete sewer	Lining: MH to MH	230
9	4100	1915-0716	1915-0726	COWLIN AV	Fractures: 252'	Structural integrity intact. No action needed.	
10	3A22	1861-0181	1861-0182	EASTERN AV	Concrete sewer	Lining: MH to MH	311
11	3221	1861-0181	1861-0152	EASTERN AV	Concrete sewer	Lining: MH to MH	316
12	2300	1861-0184	1861-TRNK	EASTERN AV	Concrete sewer	Lining: MH to MH	273
13	2200	1861-0150	1861-0151	EASTERN AV	Concrete sewer	Lining: MH to MH	120
14	1100	1861-0387	1861-0386	WASHINGTON BV	Concrete sewer	Lining: MH to MH	190
15	0000	1861-0158	1861-0162	MC DONNELL AV	Concrete sewer	Lining: MH to MH	303
16	0000	1861-0162	1861-0163	MC DONNELL AV	Concrete sewer	Lining: MH to MH	308
17	0000	1861-0163	1861-0164	DUNHAM ST	Concrete sewer	Lining: MH to MH	292
18	0000	1861-0165	1861-0164	DUNHAM ST	Concrete sewer	Lining: MH to MH	191
19	0000	1861-0167	1861-0164	MC BRIDE AV	Concrete sewer	Lining: MH to MH	303

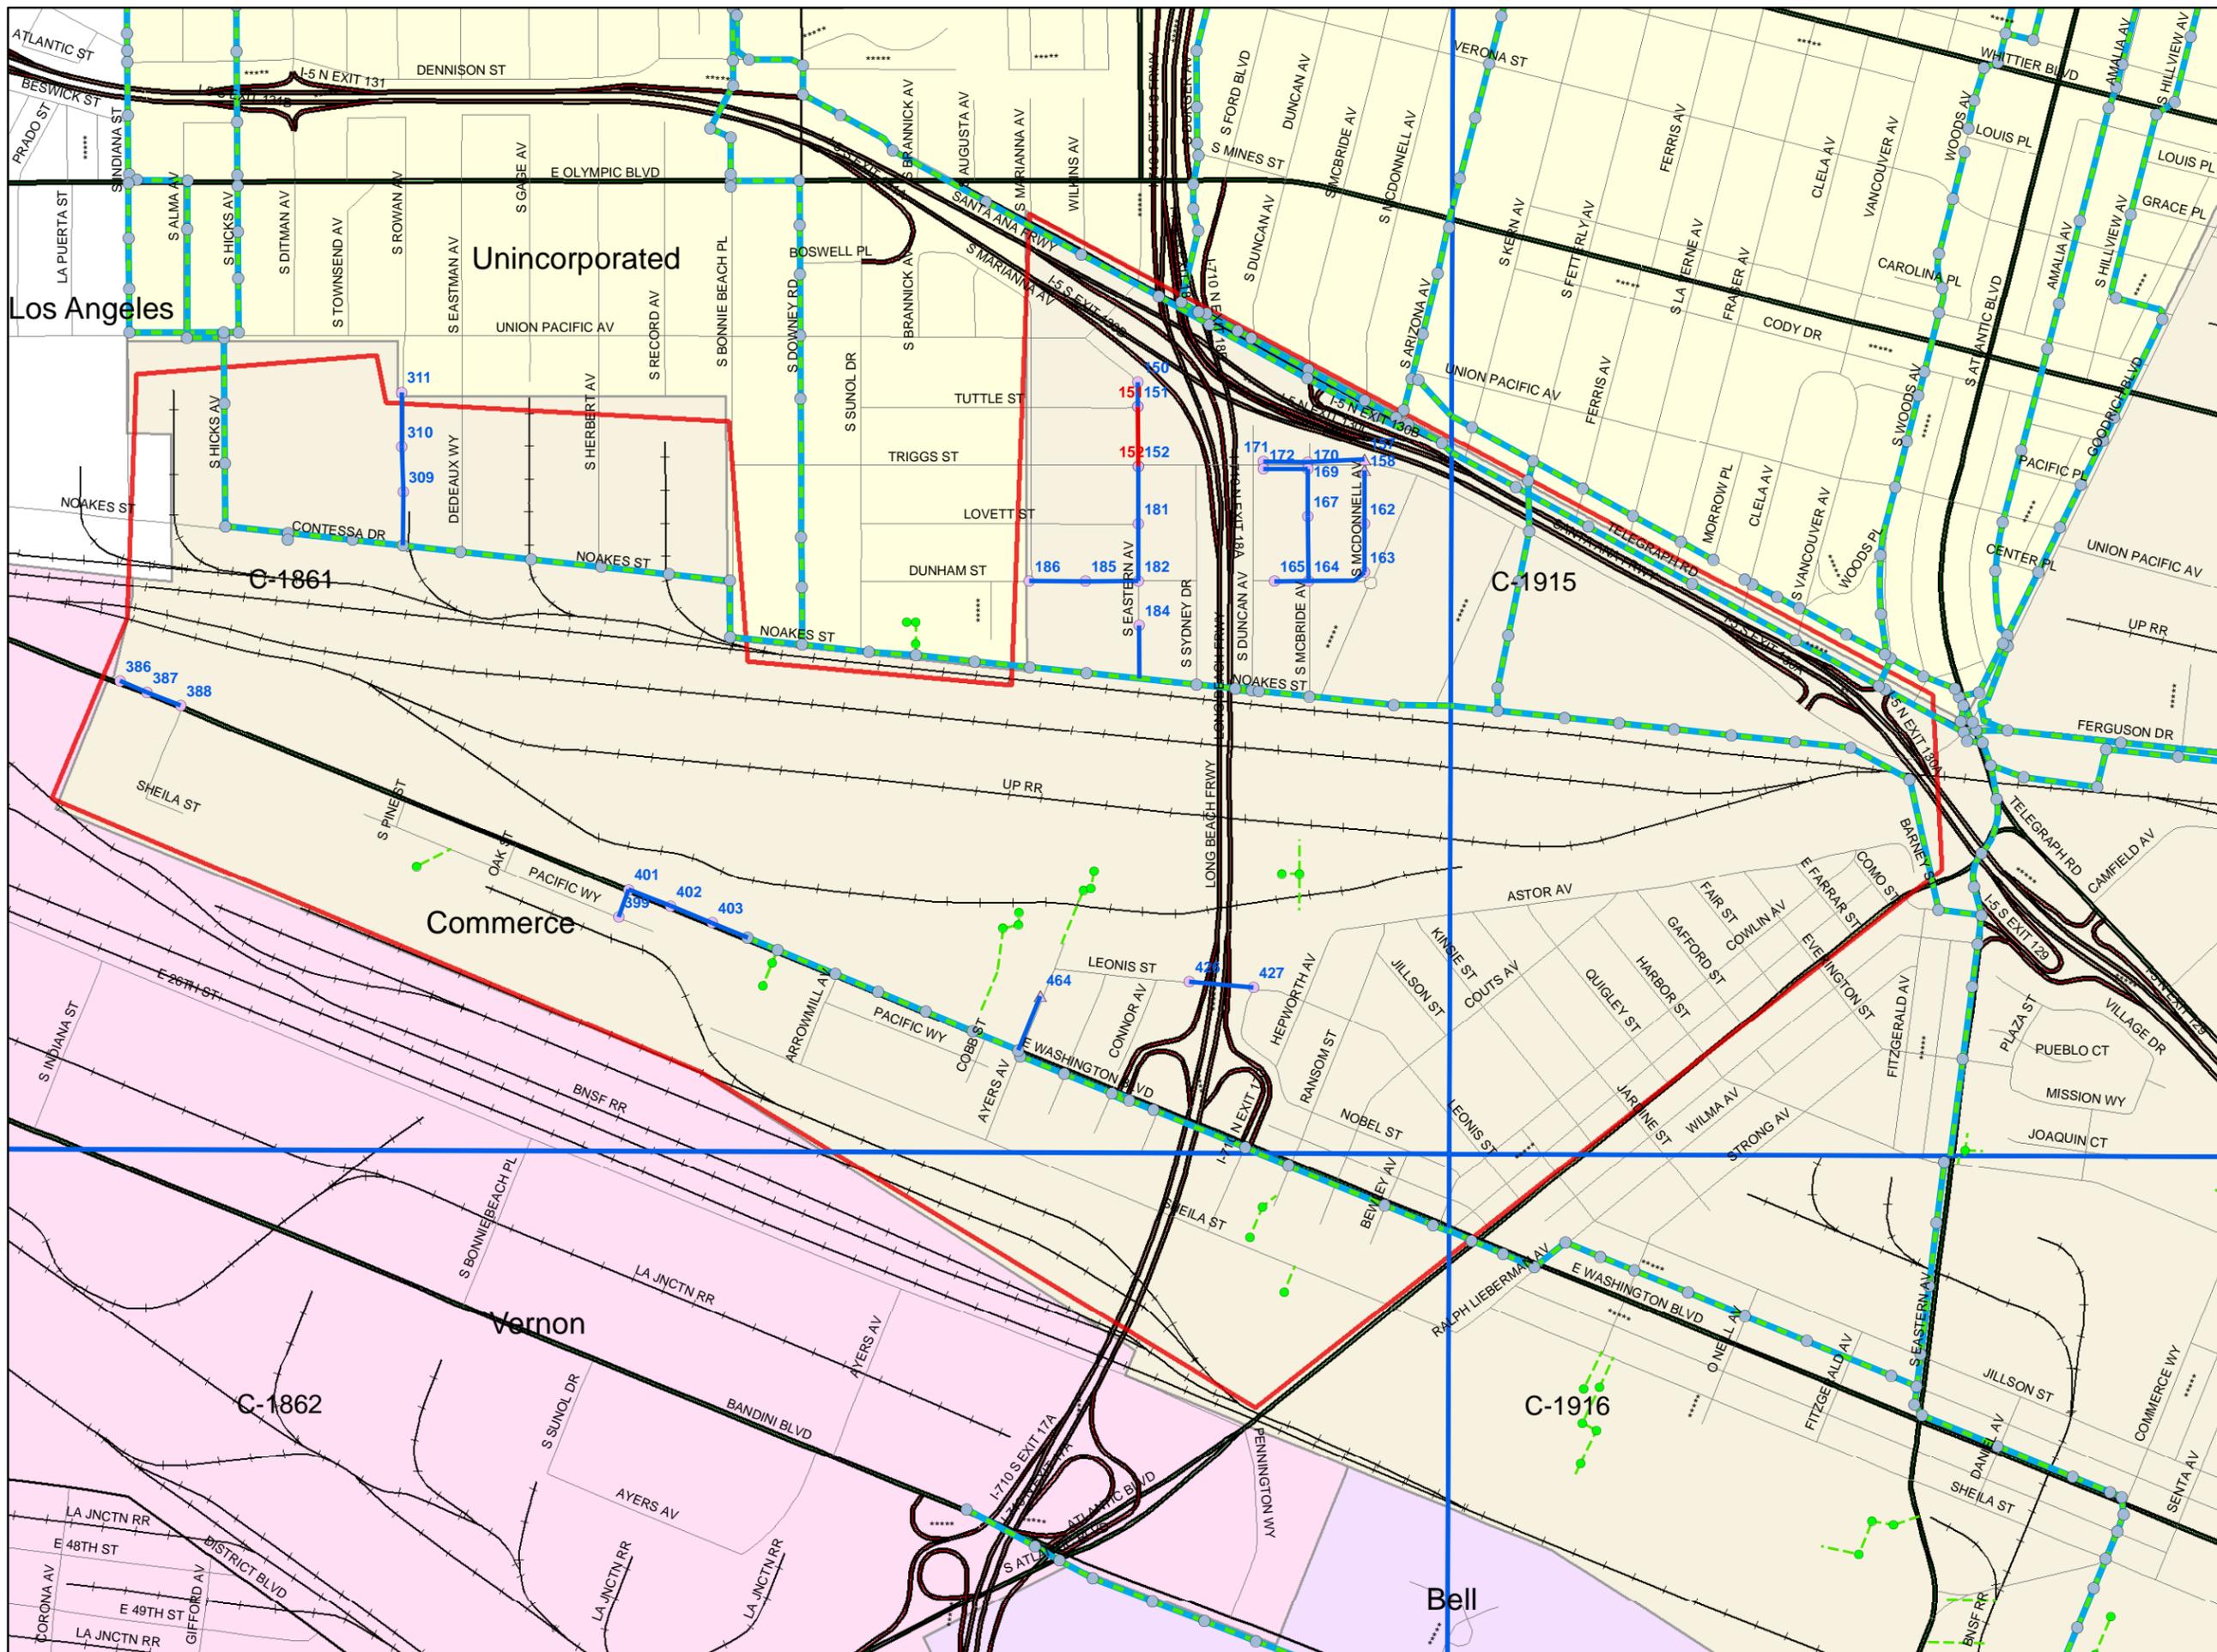
**LINING &
 POINT REPAIR**

Moreover, an additional 23 segments of sewers in this area are presently concrete pipes, which require rehabilitation through the installation of a pipe liner. Over time, concrete readily deteriorates in the presence of hydrogen sulfide gases produced in sewers. The installation of a plastic pipe liner will restore structural stability for these sewers for another 50 years. A map showing the sewer lines that need lining and point repair is also provided in Enclosure 3.

20	0000	1861-0169	1861-0157	TRIGGS ST	Concrete sewer	Lining: MH to MH	303
21	0000	1861-0170	1861-0167	MC BRIDE AV	Concrete sewer	Lining: MH to MH	308
22	0000	1861-0170	1861-0172	TRIGGS ST	Concrete sewer	Lining: MH to MH	192
23	0000	1861-0185	1861-0182	DUNHAM ST	Concrete sewer	Lining: MH to MH	292
24	0000	1861-0186	1861-0185	DUNHAM ST	Concrete sewer	Lining: MH to MH	294
25	0000	1861-0309	1861-TRNK	ROWAN AV	Concrete sewer	Lining: MH to MH	237
26	0000	1861-0310	1861-0309	ROWAN AV	Concrete sewer	Lining: MH to MH	259
27	0000	1861-0311	1861-0310	ROWAN AV	Concrete sewer	Lining: MH to MH	261
28	0000	1861-0388	1861-0387	WASHINGTON BV	Concrete sewer	Lining: MH to MH	200
29	0000	1861-0401	1861-0399	ASH ST	Concrete sewer	Lining: MH to MH	123
30	0000	1861-0401	1861-0402	WASHINGTON BV	Concrete sewer	Lining: MH to MH	293
31	0000	1861-0403	1861-0402	WASHINGTON BV	Concrete sewer	Lining: MH to MH	290
32	0000	1861-0403	1861-TRNK	WASHINGTON BV	Concrete sewer	Lining: MH to MH	290
